Geomorphic changes induced by the April-May 2015 earthquake sequence in the Pharak-Khumbu area (Nepal)

Monique Fort

Monique Fort. Geomorphic changes induced by the April-May 2015 earthquake sequence in the Pharak-Khumbu area (Nepal). EGU General Assembly 2016, Apr 2016, Vienna, Austria. 2014. hal-01373222

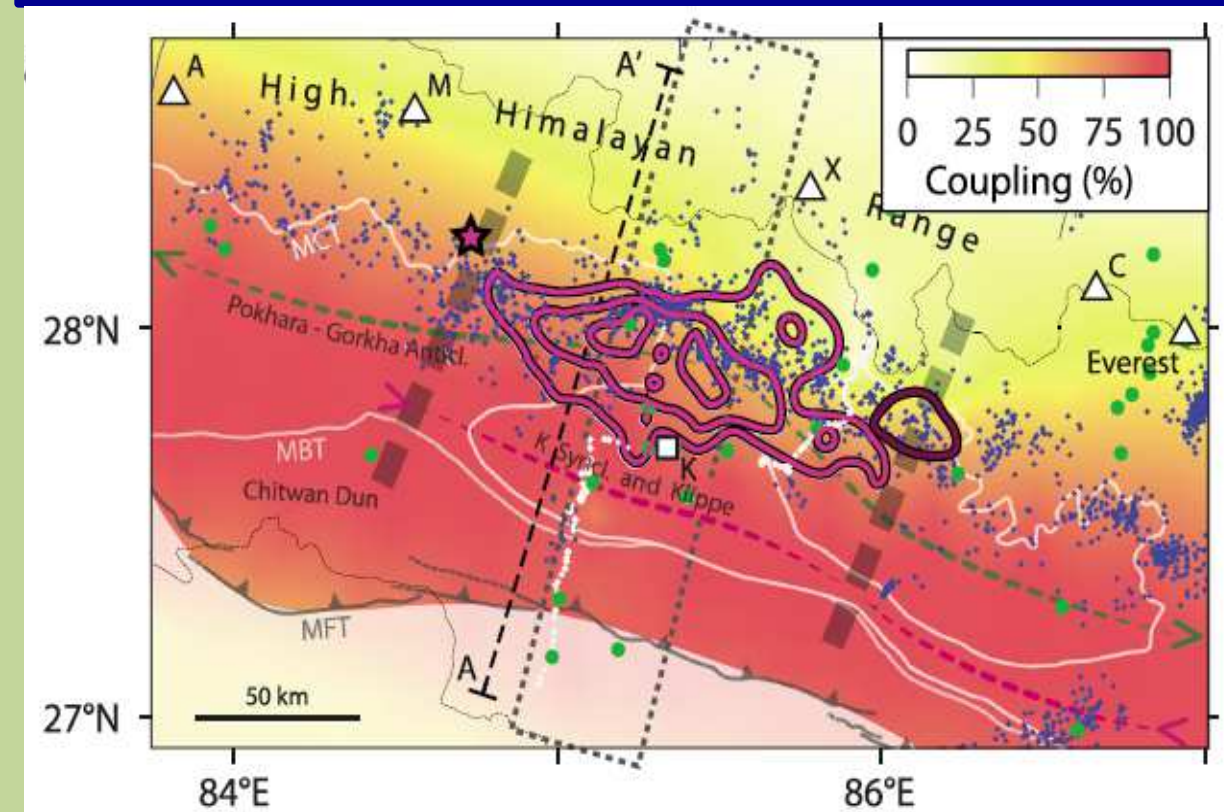
Interseismic coupling distribution on the Main Himalayan Thrust (MHT) deduced from GPS (green circles) and leveling (white circles). Slip contours of the 2015 Gorkha earthquake (25 April) and its main aftershock (12 May) are indicated by pink and brown lines, respectively (Grandin et al. 2015).

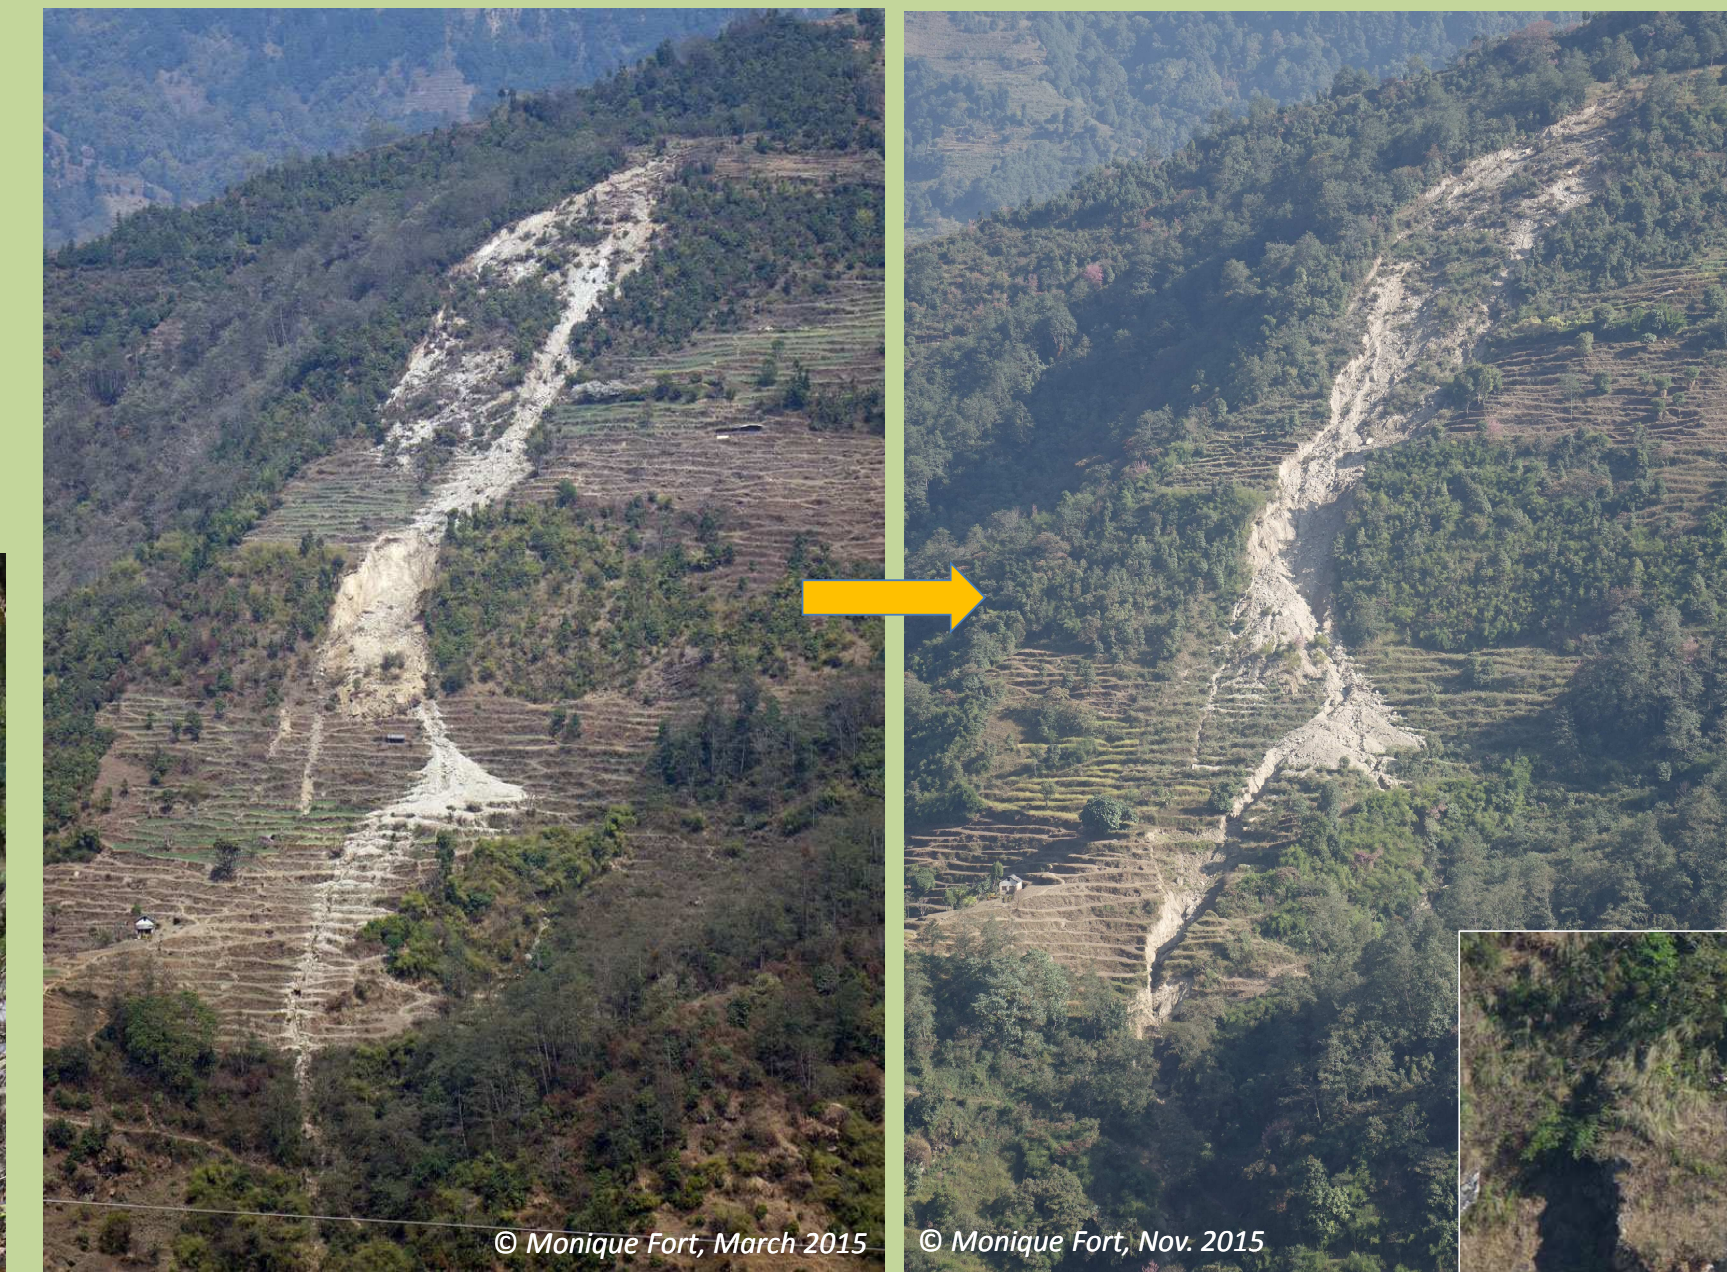
Near Paya (left), slope collapse was controlled by the talweg. Older, very coarse debris were removed, destroyed the foot trail and filled in the talweg.

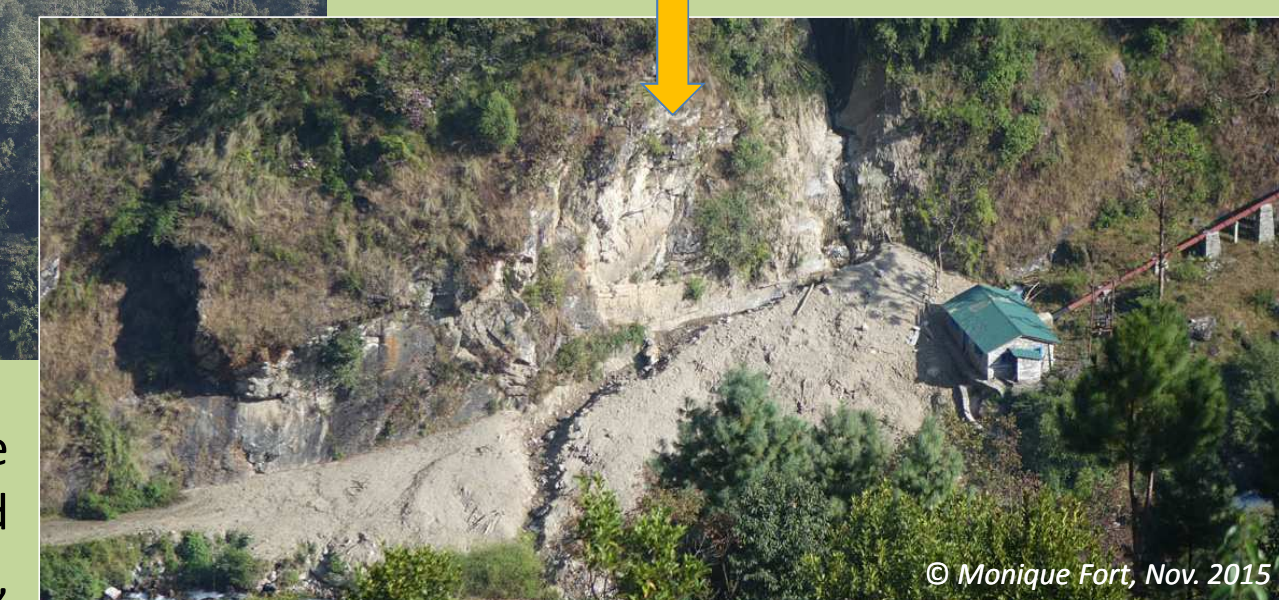
Cascading processes often result in temporary valley damming, as observed upstream of Jubing (right) and near Bupsa (above), with the new hydropower station damaged).

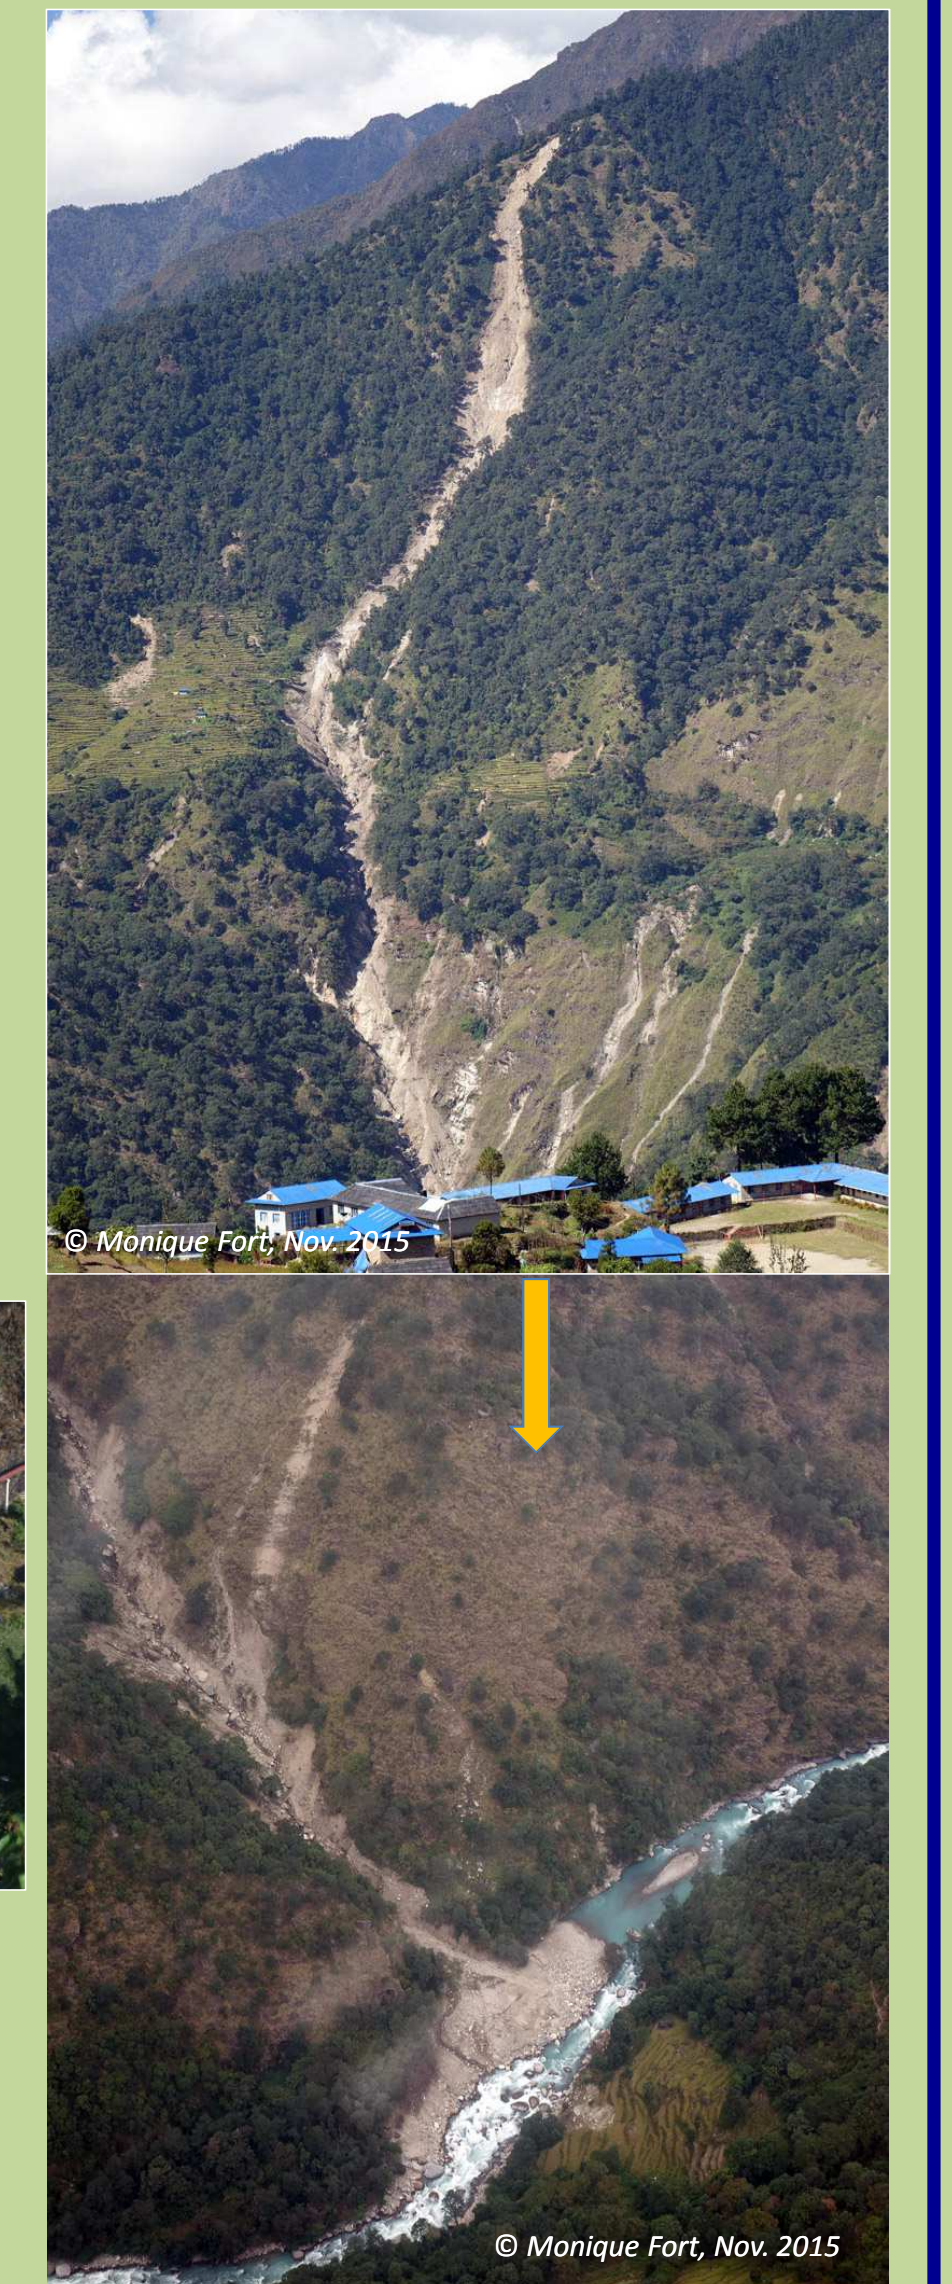
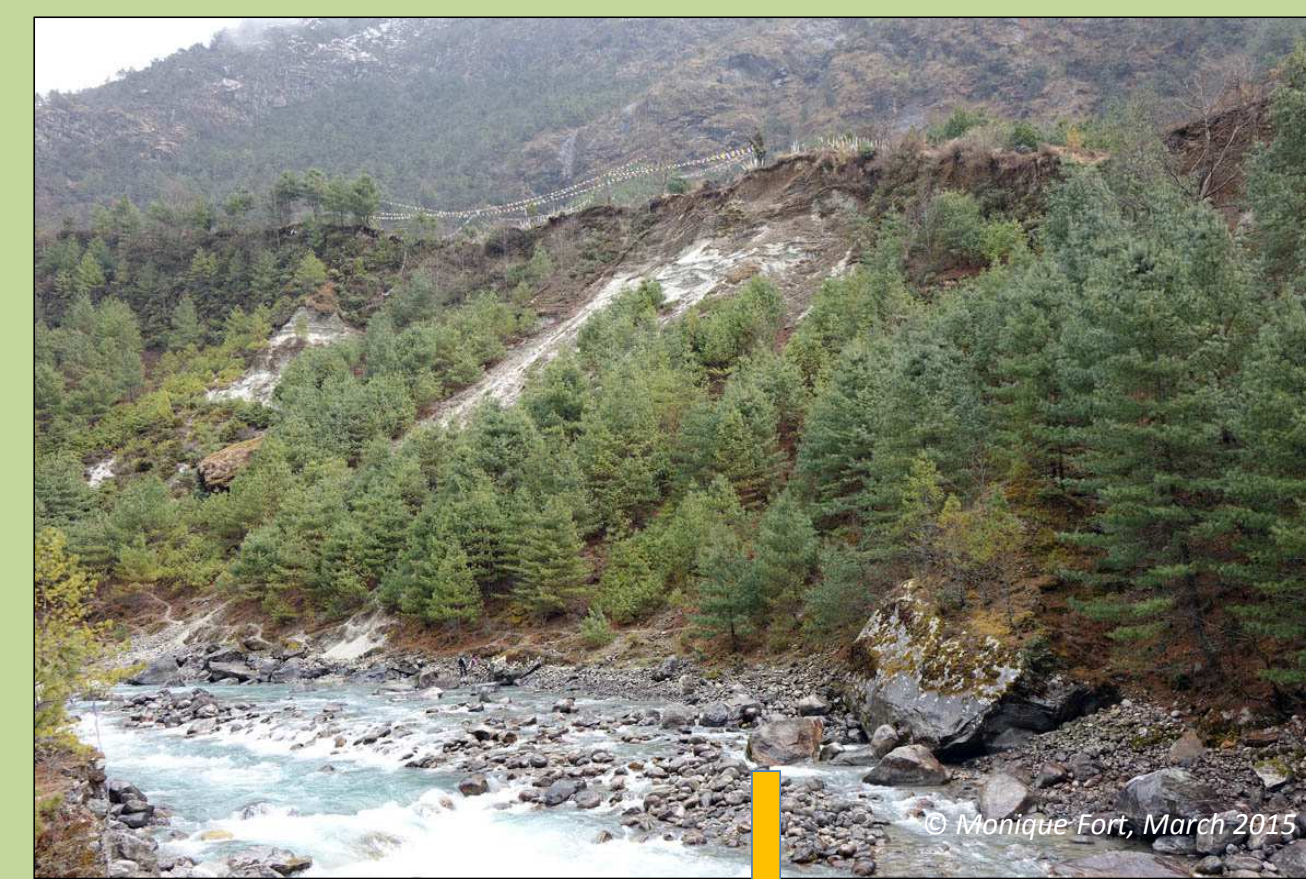
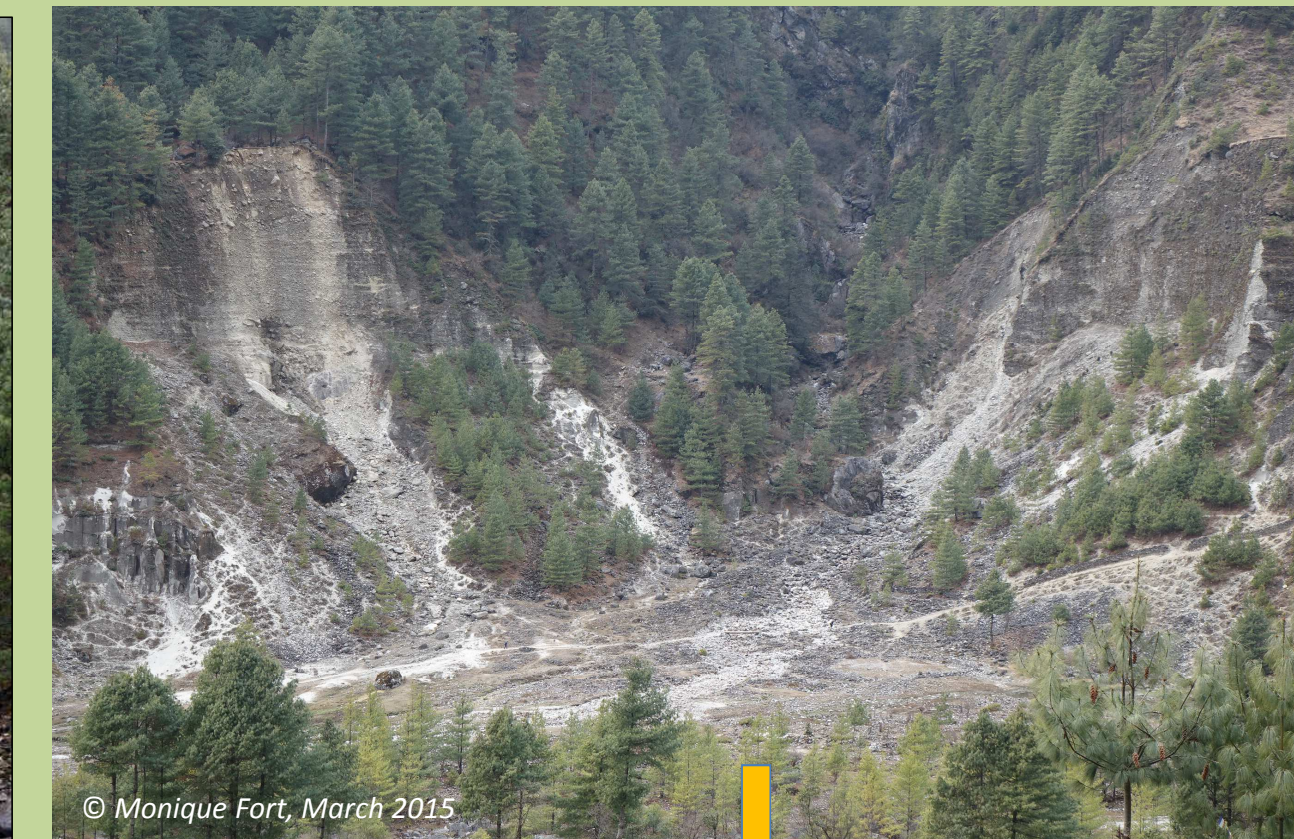
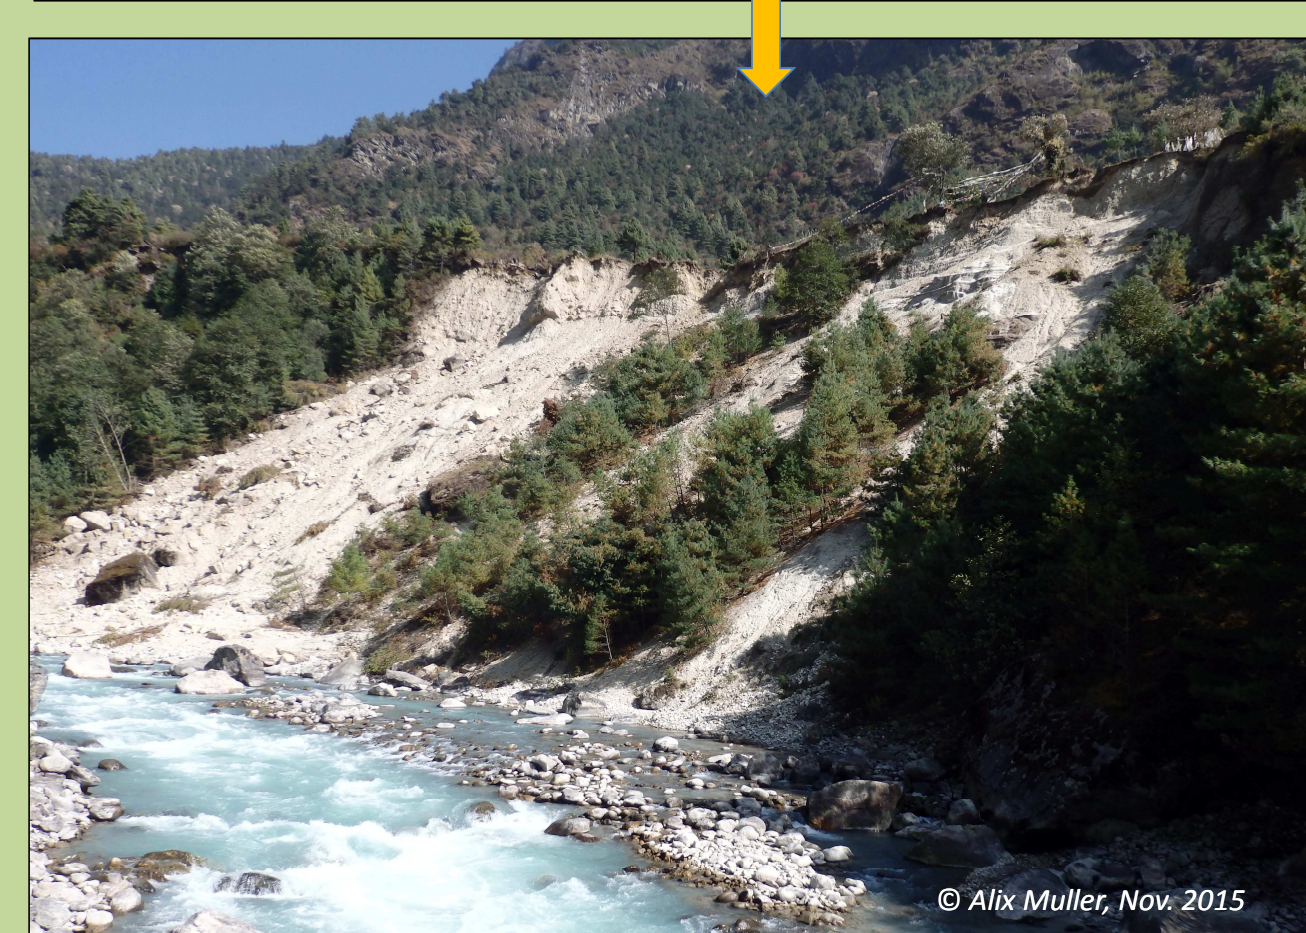
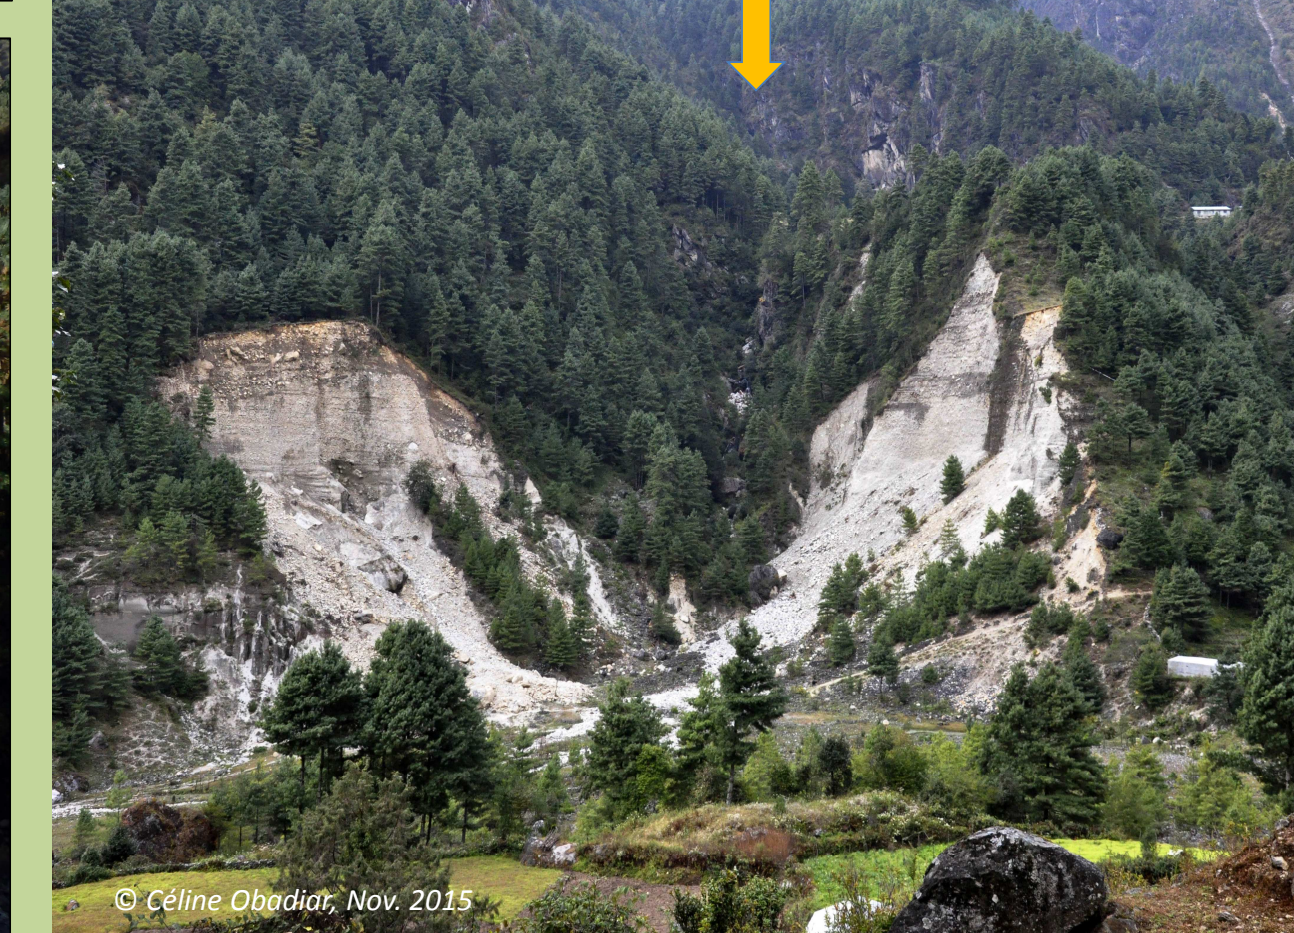
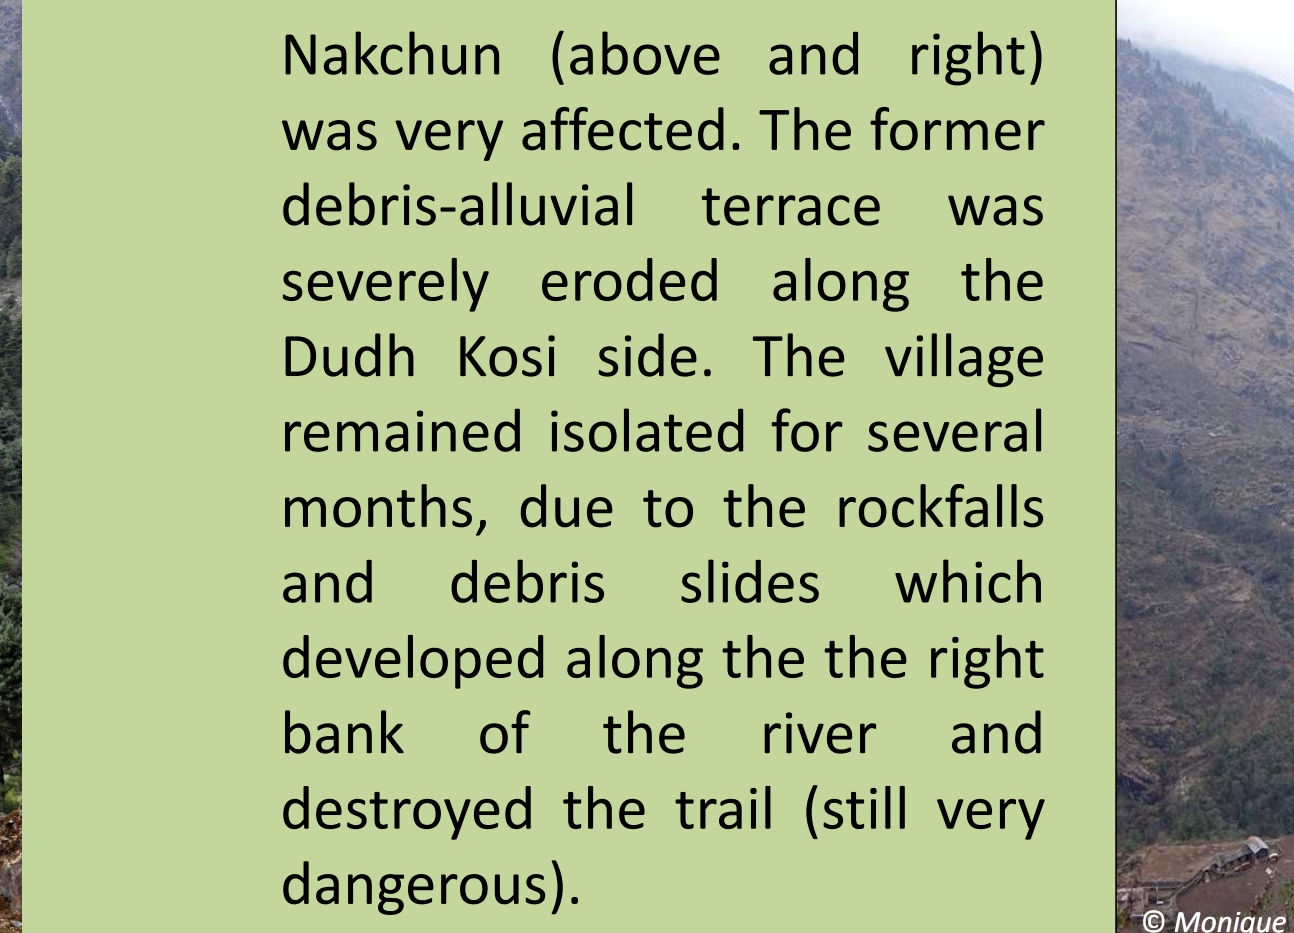
Nakchun (above and right) was very affected. The former debris-alluvial terrace was severely eroded along the Dudh Kosi side. The village remained isolated for several months, due to the rockfalls and debris slides which developed along the the right bank of the river and destroyed the trail (still very dangerous).
